Extended Grease Point

Innovation Purpose

INNOVATION   **CHALLENGE**

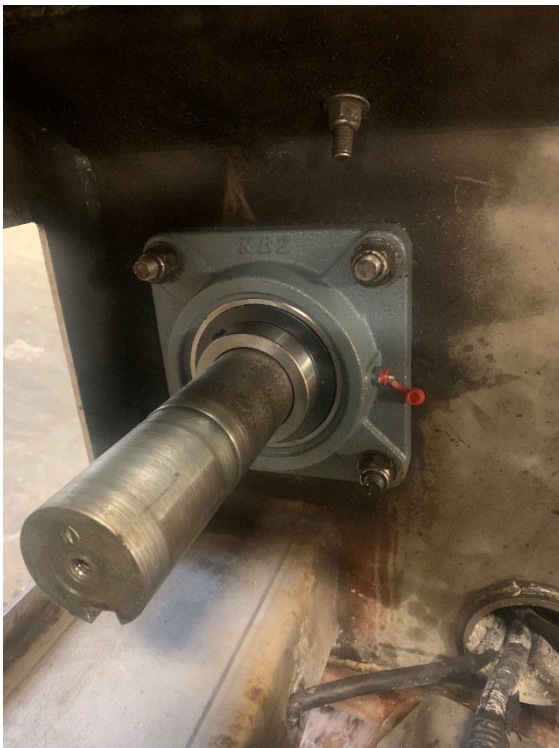
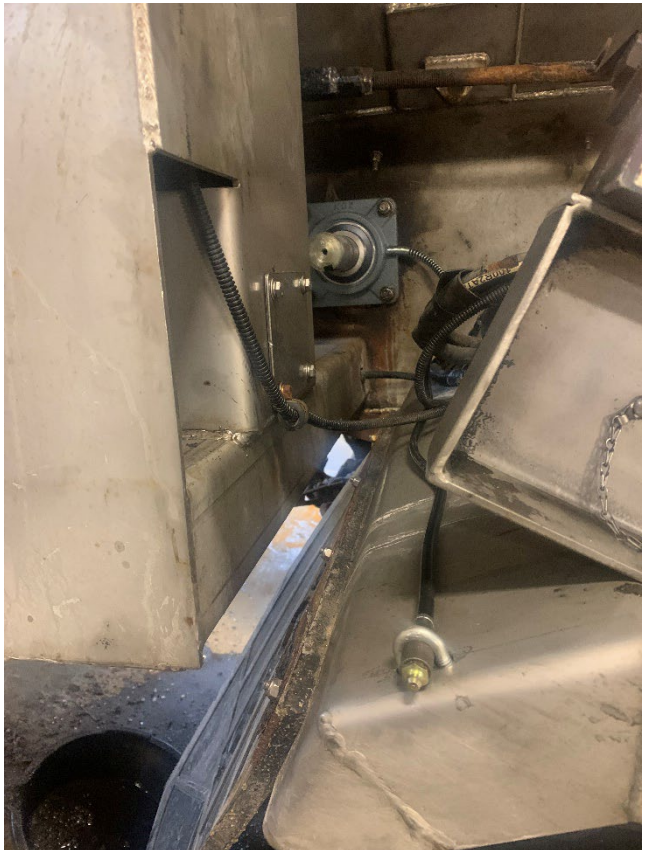
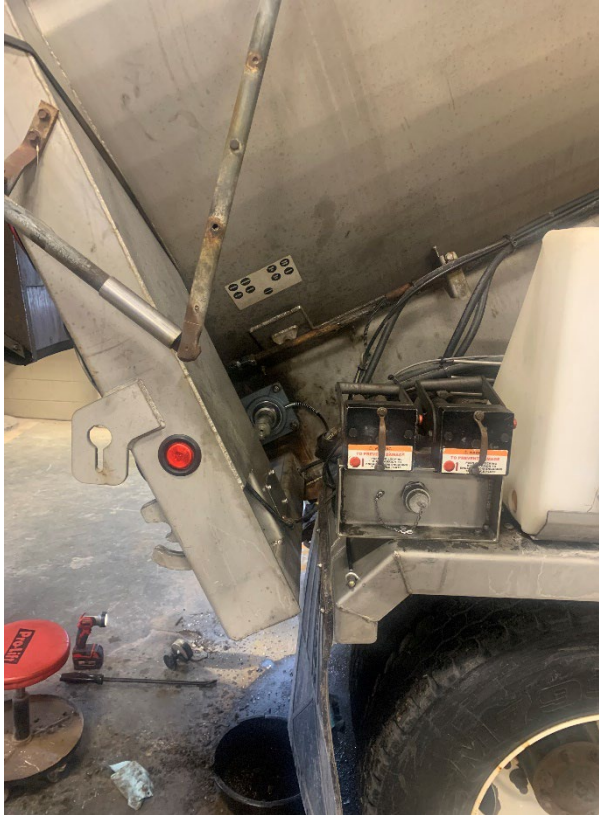
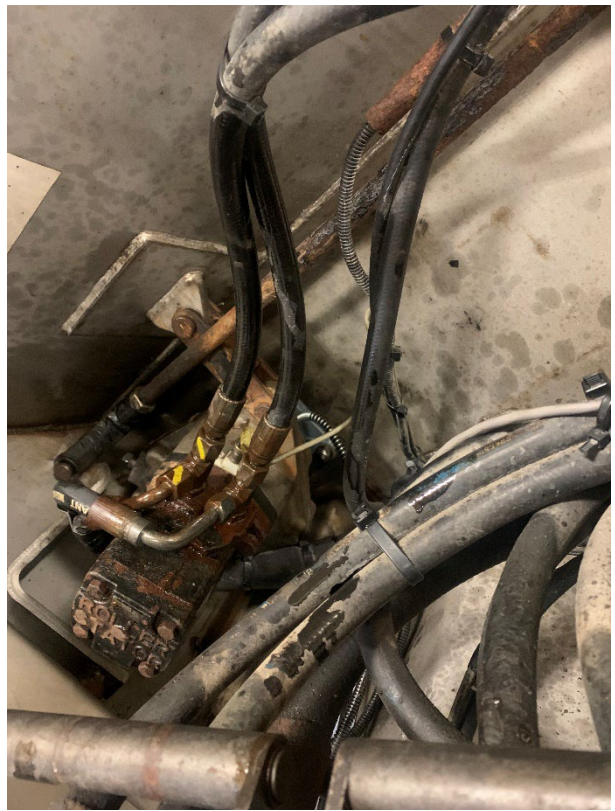
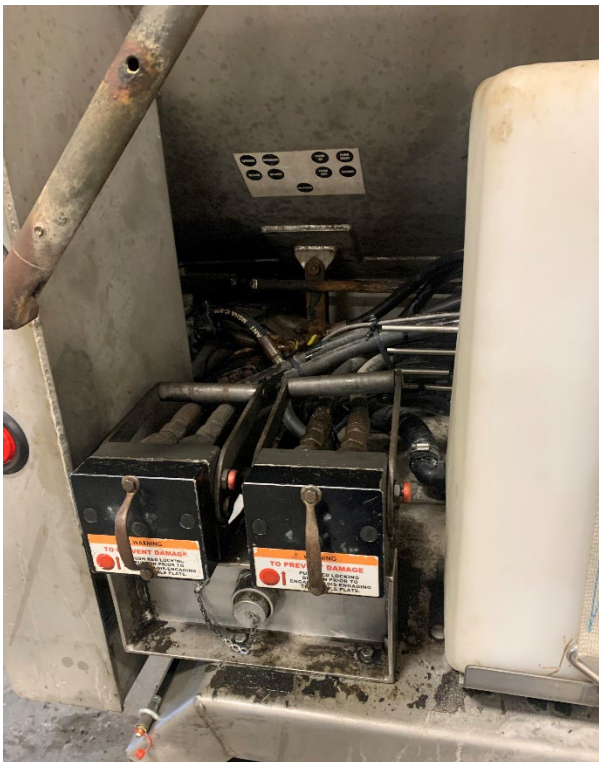
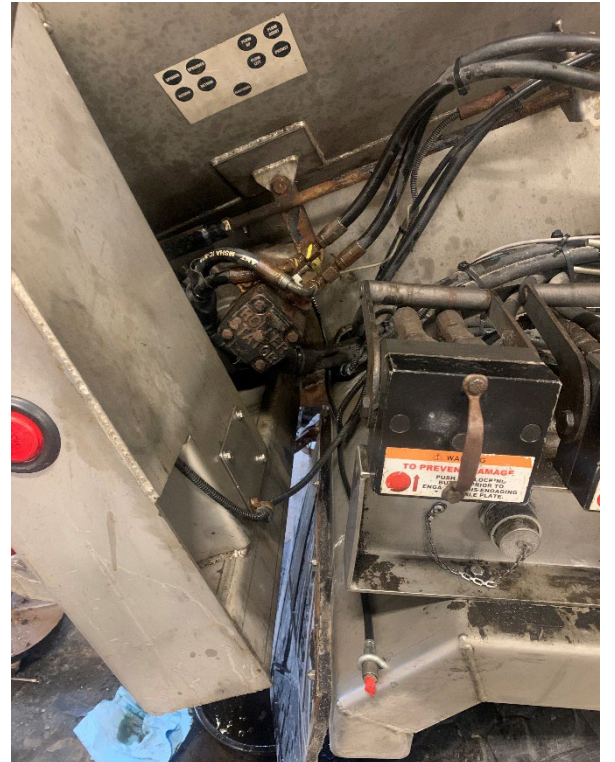
On RDS dump trucks, the floor chain bearings on the rear of the truck were not getting greased because it was very hard to access the grease fitting, causing bearing failure.

We purchased an extended grease gun hose and installed it on the bearing, then fastened it to the rear fender to make greasing the bearing much easier.
